# Loss of Signal

*Aeromedical Lessons Learned from the STS-107 Columbia Space Shuttle Mishap*

Executive Editor  
**Philip C. Stepaniak**

Editor in Chief  
**Helen W. Lane**

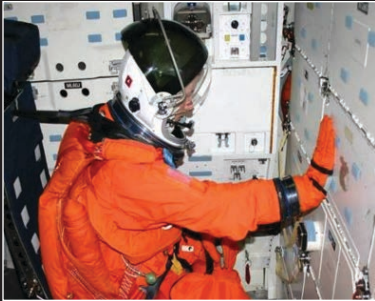
Demonstration of possible bracing position in the middeck.

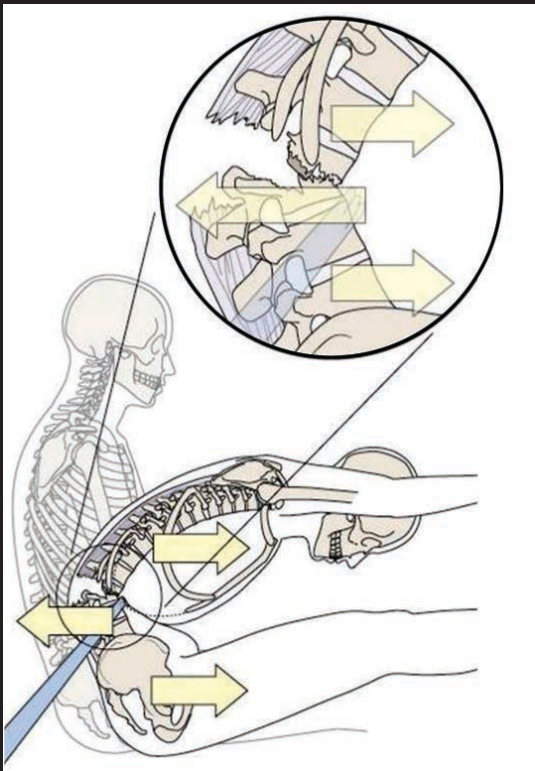
All crewmembers had exhibited upper and lower extremity fractures consistent with deceleration injury (G flail) before CMCE and aerodynamic flail after CMCE and exposure to windblast. Using a model that analyzed the possible strike envelopes of the seated crew, correlation was found between the possible injury locations and the actual sites. The static flail analysis predicted that most injuries would be located in the distal limbs and parietal skull, with some slight variations due to crewmember seat location.
